**Our Client** : Miss Palminder Kaur Barar  
**Subject** : Webbers Cottage, Coleshill Lane, Amersham, HP7 0NS ("the Property")

## Arboricultural Consultancy for Covéa Insurance

# GEOTECHNICAL

Webbers Cottage, Coleshill Lane, Amersham, HP7 0NS

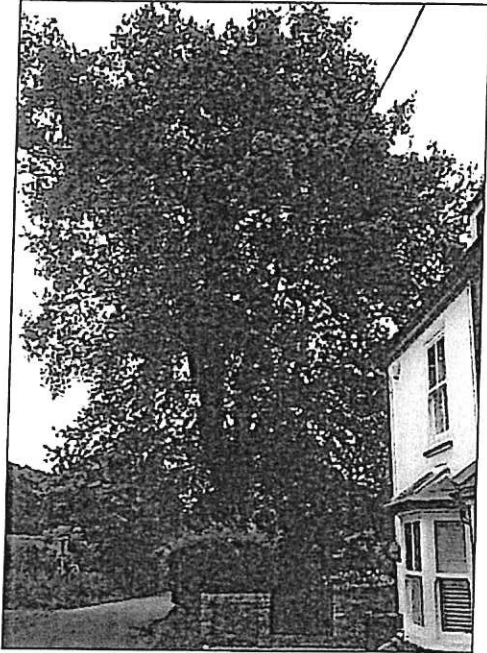
T1 - Oak

Based on our observations on site, T1 (Oak) will, in our opinion, be the source of the *Quercus* spp roots recovered from TP/BH1.

Given the above, T1 (Oak) is considered to be implicated in the current subsidence damage.

In assessing the potential drying influence of the vegetation on site, T1 (Oak) is clearly the dominant feature proximate to the front of the insured property and accordingly we have identified it as the principal cause of the subsidence damage.

The size, orientation and proximity of T1 (Oak) is consistent with the location of damage and advised mechanism of movement.

Vegetation management in the form of removal and appropriate stump treatment will help to promote the restoration of long-term stability to the insured property; pruning should not be considered as representing an effective or reliable long-term alternative solution given the size and proximity of the vegetation.

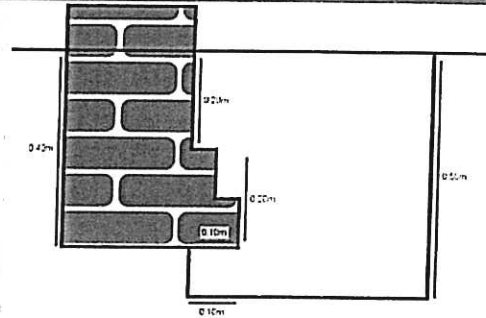
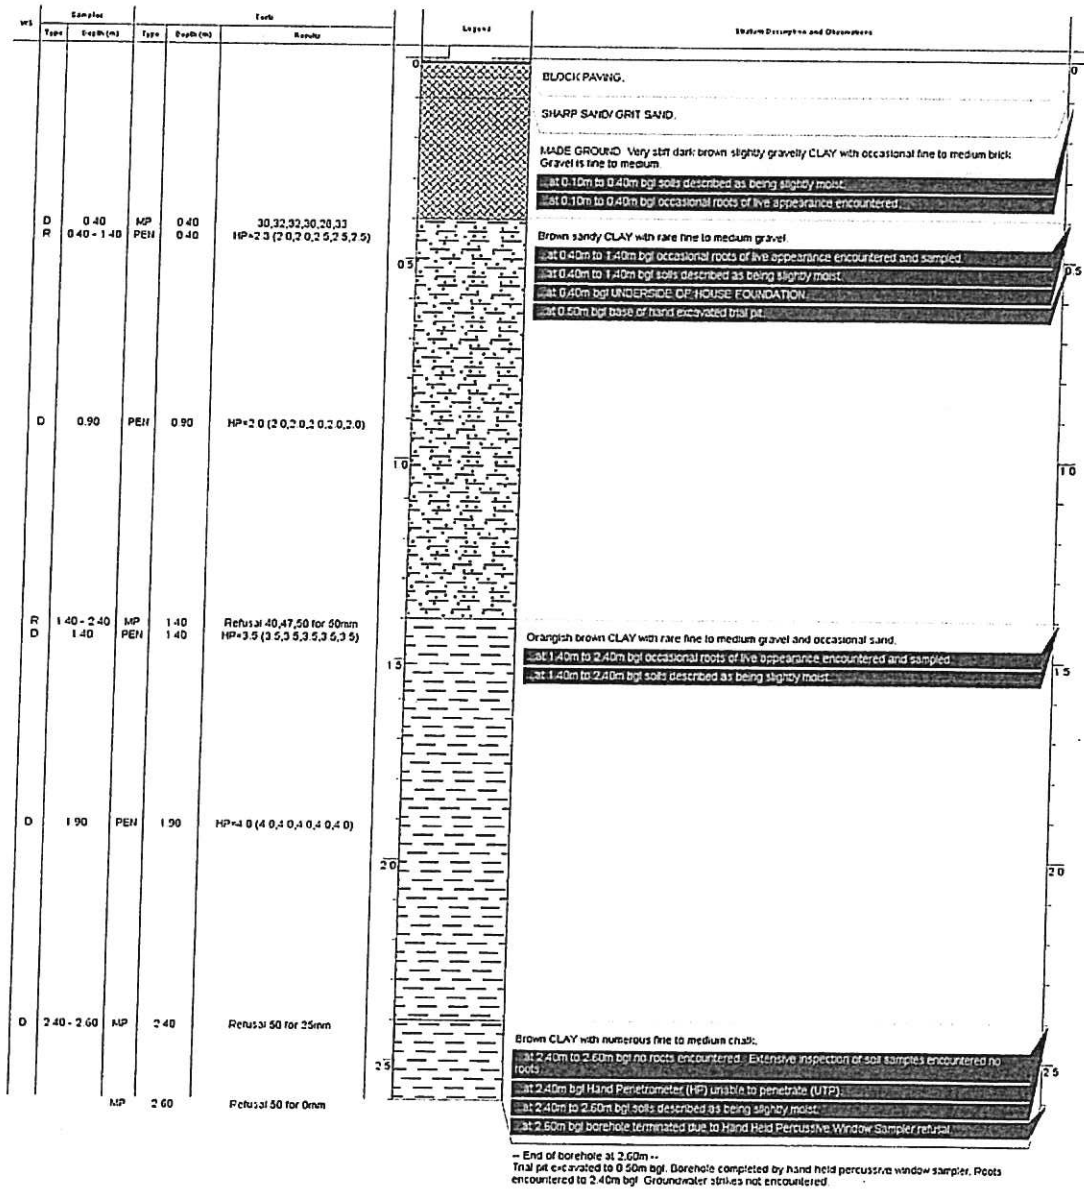
**TP/BH1 Foundation Detail and Borehole Log**

House foundation comprised of brick wall to 200mm bgl, bearing on stepped brickwork to 400mm bgl with a total projection of 100mm from the elevation. Underside of foundation (USF) was exposed to 100mm back from the face of the foundation and probed 600mm back from the face of the foundation.

House foundation was exposed and the underside of foundation (USF) recorded to be 0.40m bgl (TP/BH 1).

Hand Held Percussive Window Sampler refusal at 2.60m bgl due to (chalk) within the clay (TP/BH 1). Borehole terminated. No further works undertaken.

Roots encountered to 2.40m bgl (TP/BH 1).

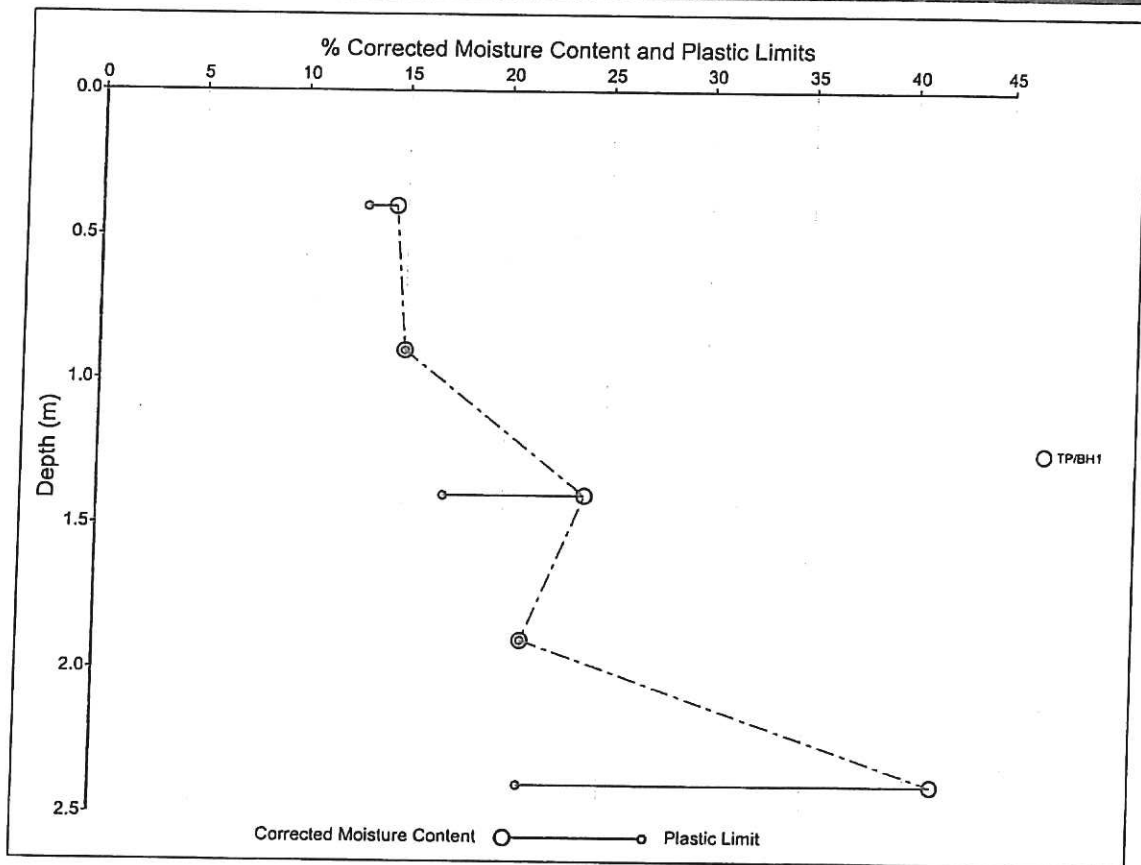
**Corrected Moisture Content and Plastic Limits Graph**

Atterberg testing for soils recovered in TP/BH1 showed the soil moisture content to be approaching (1%) the plastic limit

underside of foundations (400mm) and within 7% of plastic limit at 1400mm.

Lab Ref	Depth (m)	MC (%)	Corr MC (%)	LL (%)	PL (%)	PI (%)	% Passing .425mm
<b>Samples from TP/BH1</b>							
001	0.40	12	14	25	13	12	83
002	0.90	15					
003	1.40	24	24	56	17	39	100
004	1.90	21					
005	2.40	36	41	48	21	27	87

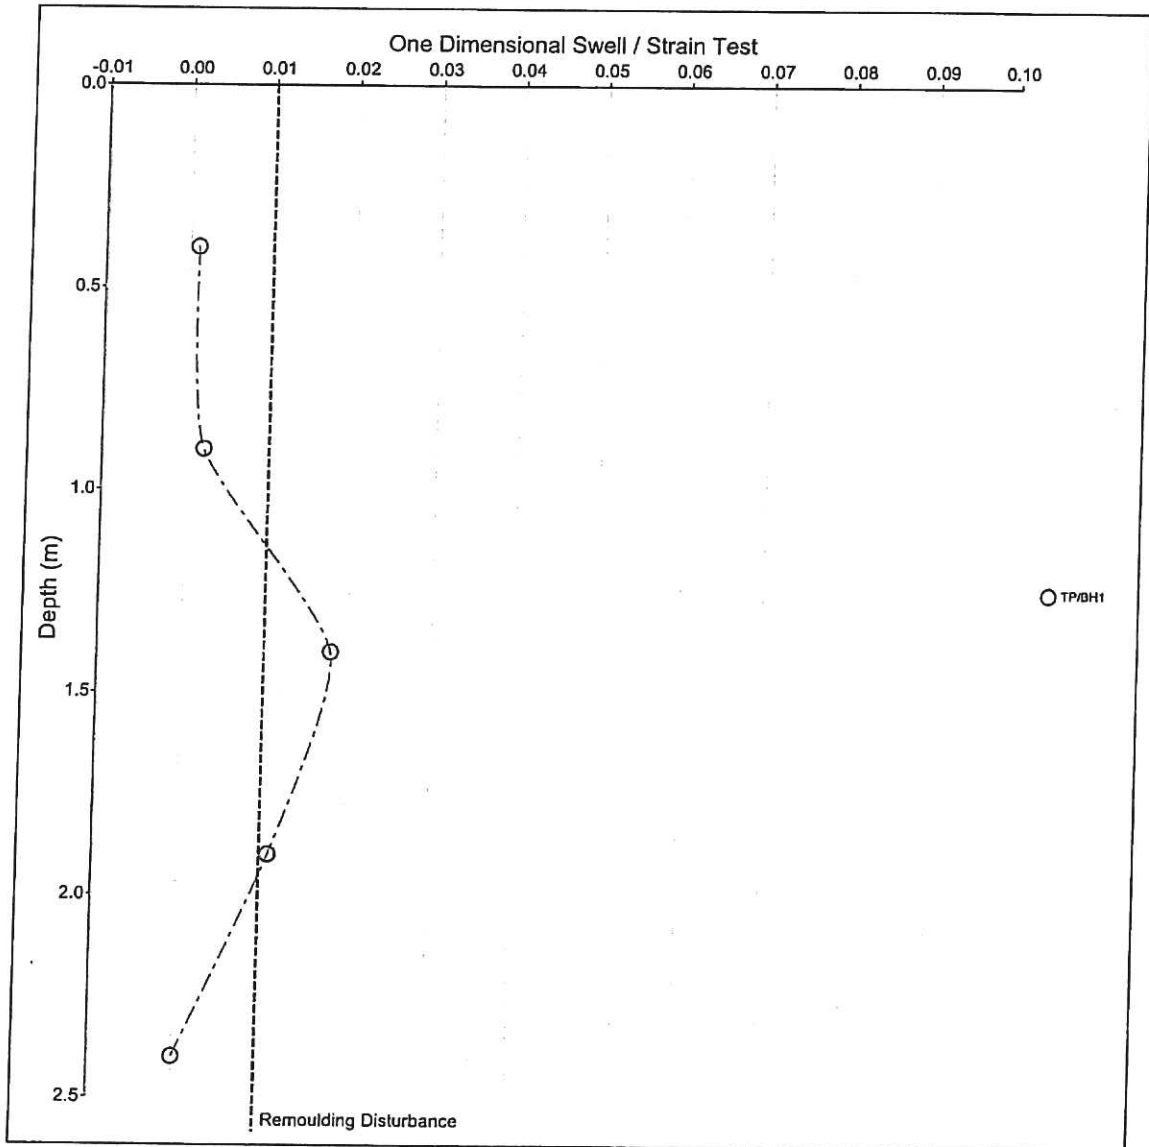
### Oedometer Strain

Lab Ref	Depth (m)	Strain	Dd (mm)	Remarks
Samples from TP/BH1				
001	0.40	0.0010	0.2	
002	0.90	0.0022	0.6	
003	1.40	0.0180	4.5	
004	1.90	0.0110	2.8	
005	2.40			Sample too soft for preparation

TP/BH1 Dd Total: 8.0mm

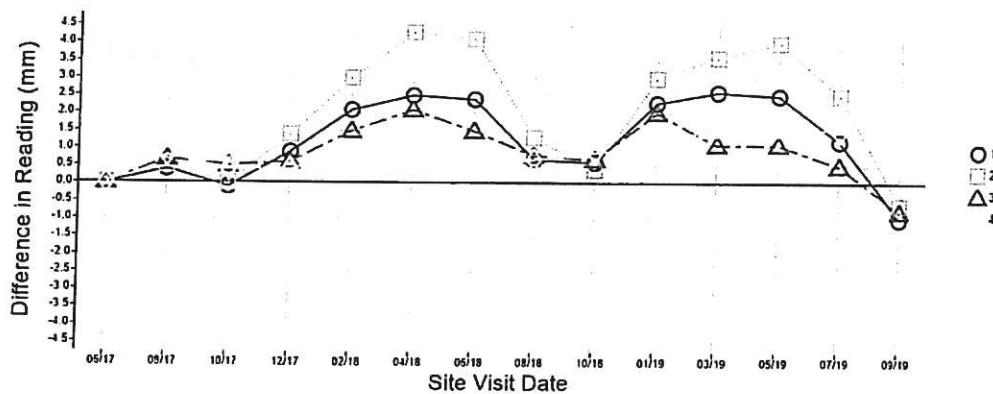
### Level Monitoring Difference Graphs

The Property has also been subject to level monitoring from 26 June 2017. The results display clear seasonal movement whilst T1 has been in-situ, which is a key indicator of clay shrinkage subsidence.

Similar movement to Feb 18 noted.

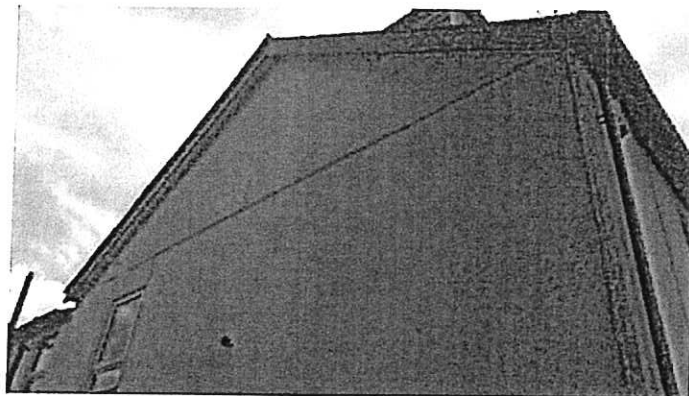
FIGURE 04 Previous repairs

There is evidence of previous repairs in the form of previous cracking running from ground to roof level. The previous cracking appears to have closed up forcing the repair out.
