Little Marlow STW Performance Summary

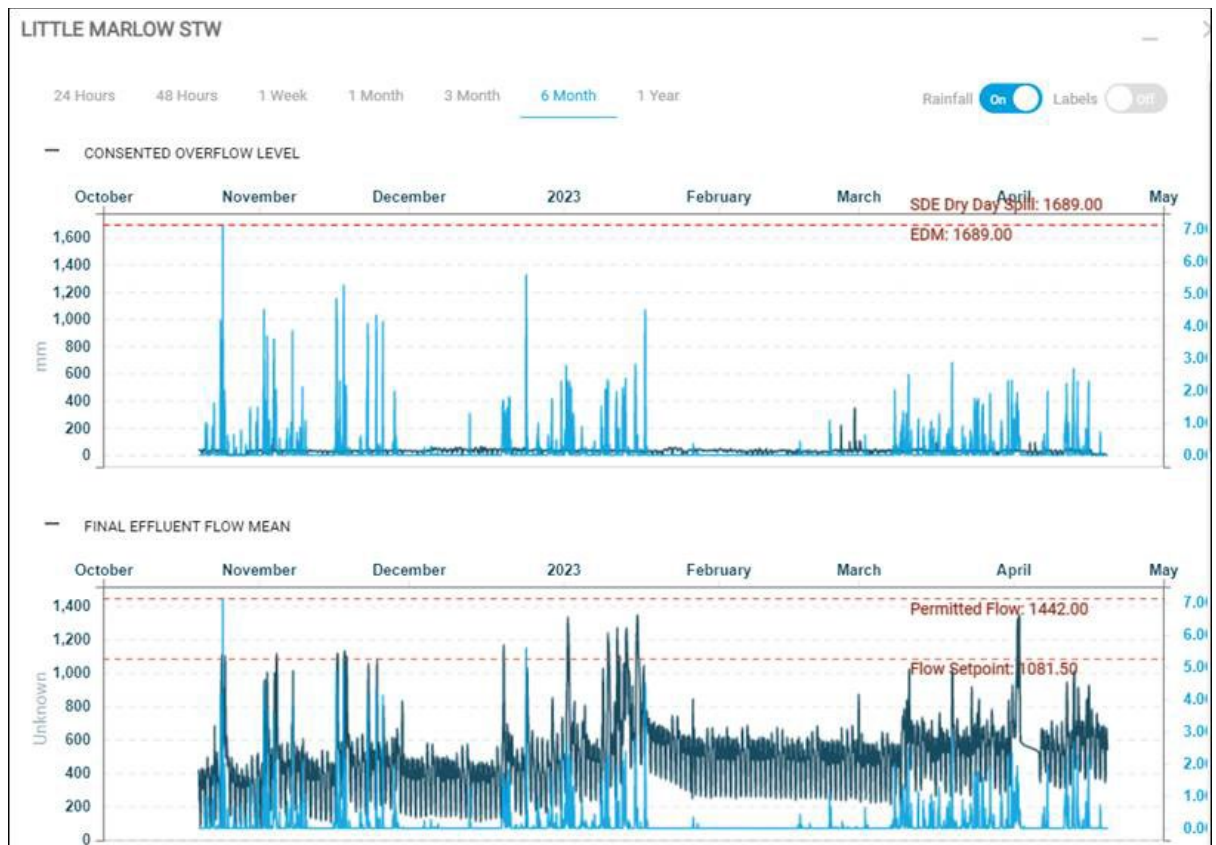
- No storm discharges – see screenshot from DAM tool below. Light blue trace shows rainfall. First graph shows no spills (spill level is indicated by red dotted line). Second graph shows final effluent flow.

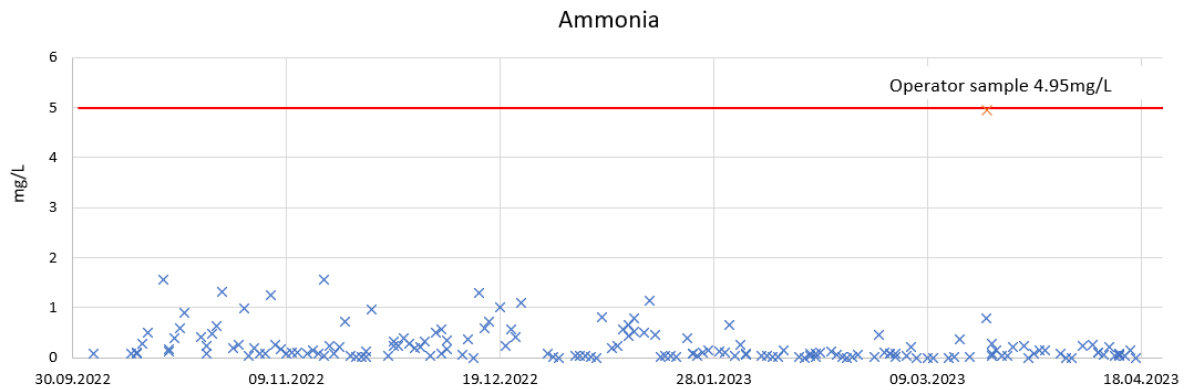
- In 2022 Little Marlow complied with the Dry Weather Flow permit (DWF volume of 25,707 m³/day compared to permit level 40,300 m³/day).
- All regulatory samples compliant with permit for water quality (no failed OSM or shadow samples or UWWR) – graphs showing AmmN, BOD and SS below. Red lines show permit level

Elevated sample on 23/3/23 was due to aeration blowers tripping – see elogbook entry below. Problem quickly identified and resolved, with AmmN returning to normal within a few hours
