# Langrish Boat 23 Pidham Lane East Meon Five Ways Maintenance and Repairs

Loddon Vale Trail Riders Fellowship  
& Hants CC joint co-operation

## Langrish 23 Repair Scope (July 2016)

## Langrish 23 Repair Site Visit (21Jan17)

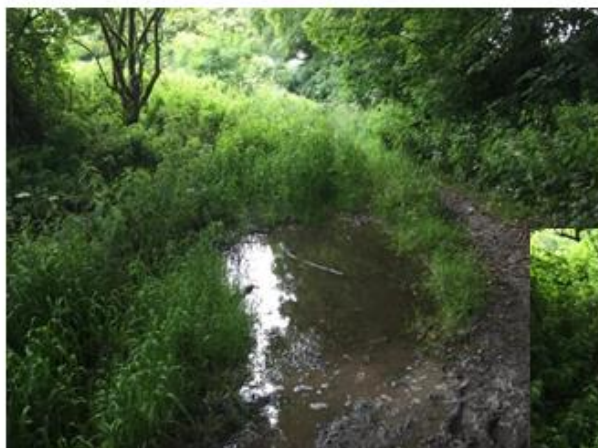
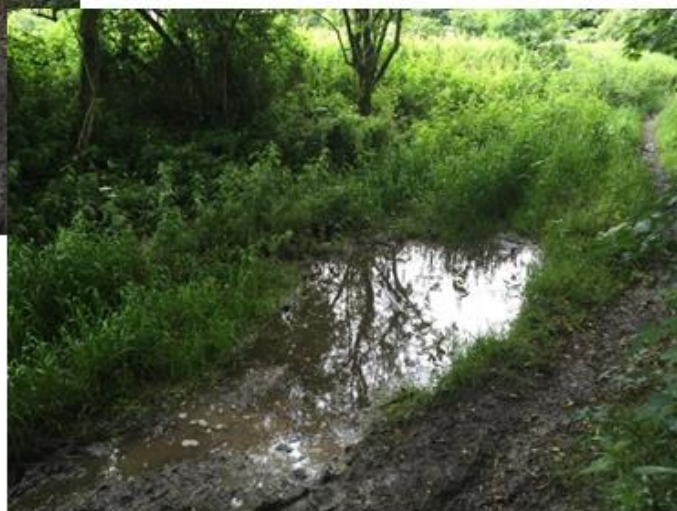
### large pools + fallen trees

Access for horse riders and walkers is becoming difficult due to large pools forming in several areas and falling trees.

Pools require draining, filling with hard core and new surface formed with scalpings. Trees require to be cut up and cleared. Drainage can be improved to reduce water damage.

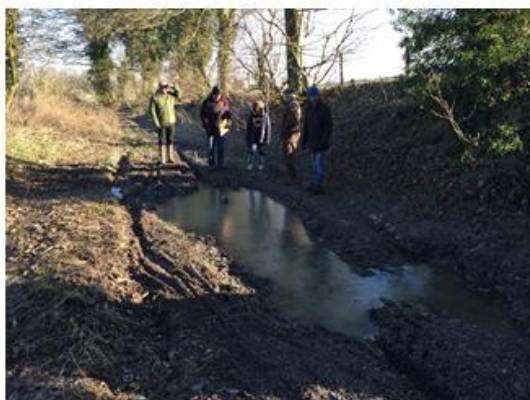
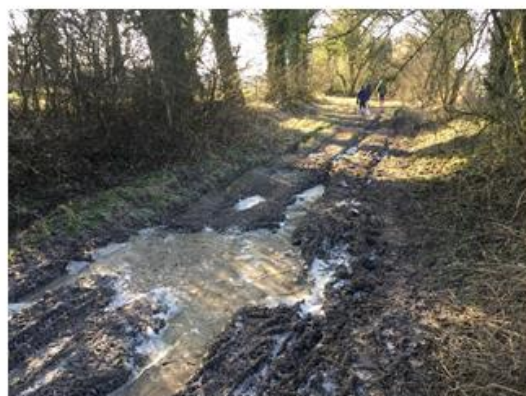
### 3 large holes and rutting

Large holes are still evident from water damage/drainage issues, but rutting due to use / field access has increased since July 2016.

Suggestion to increase quantities of materials by 50% to ensure the scope can be fully completed and drainage improved. Any excess materials can be used 50m further up the byway.
