## UPDATE ON FLOODING AT THE WILLOWS, AYLESBURY AND OTHER PLACES ACROSS AYLESBURY VALE IN FEBRUARY 2014

### 1 Purpose

- 1.1 To provide an update on actions taken to prevent a recurrence of events that occurred during the flooding events in February 2014.

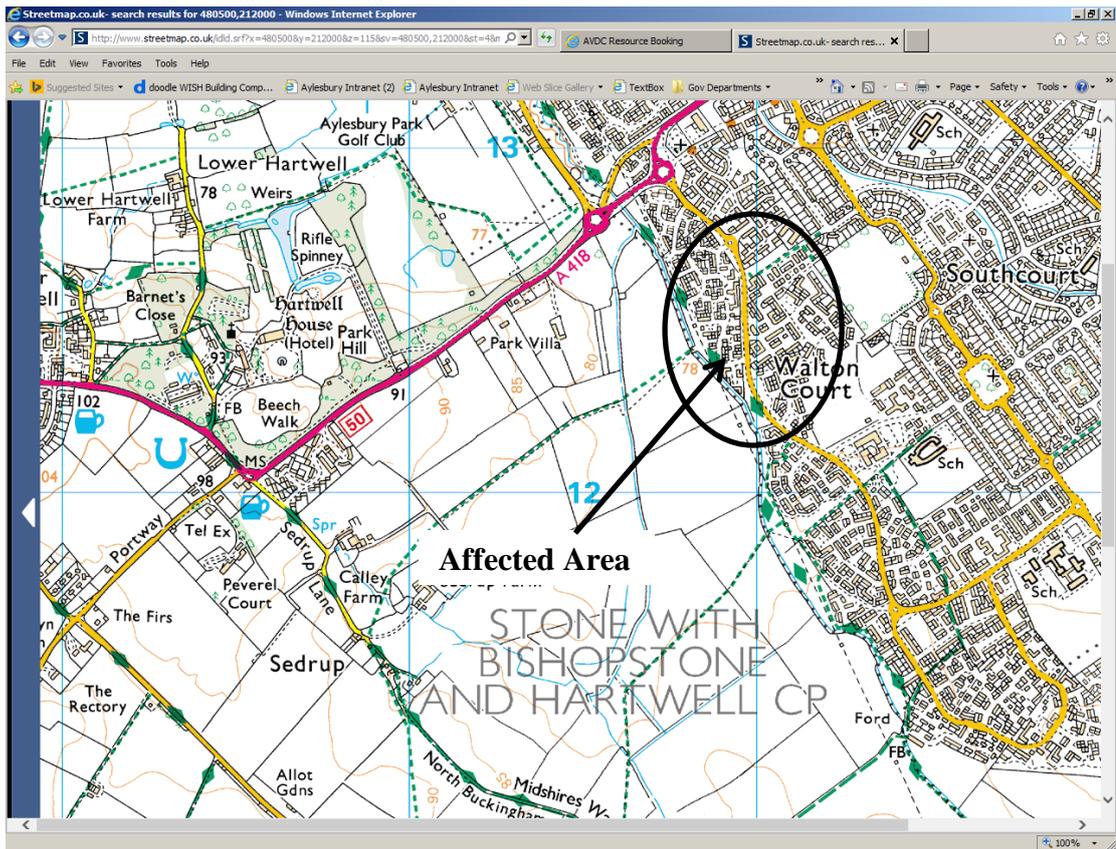
Figure 1 - Area of “The Willows Estate” Aylesbury affected by flooding

- 3.6 79 properties were flooded internally on the Willows Estate in Aylesbury – see Figure 1 – due to the Stoke Brook being overwhelmed. Only two households (totalling 5 people) were evacuated to an overnight rest centre arranged by AVDC for one night. Local Media coverage was extensive, with AVDC, BCC and the Environment Agency all questioned over their actions and policies.

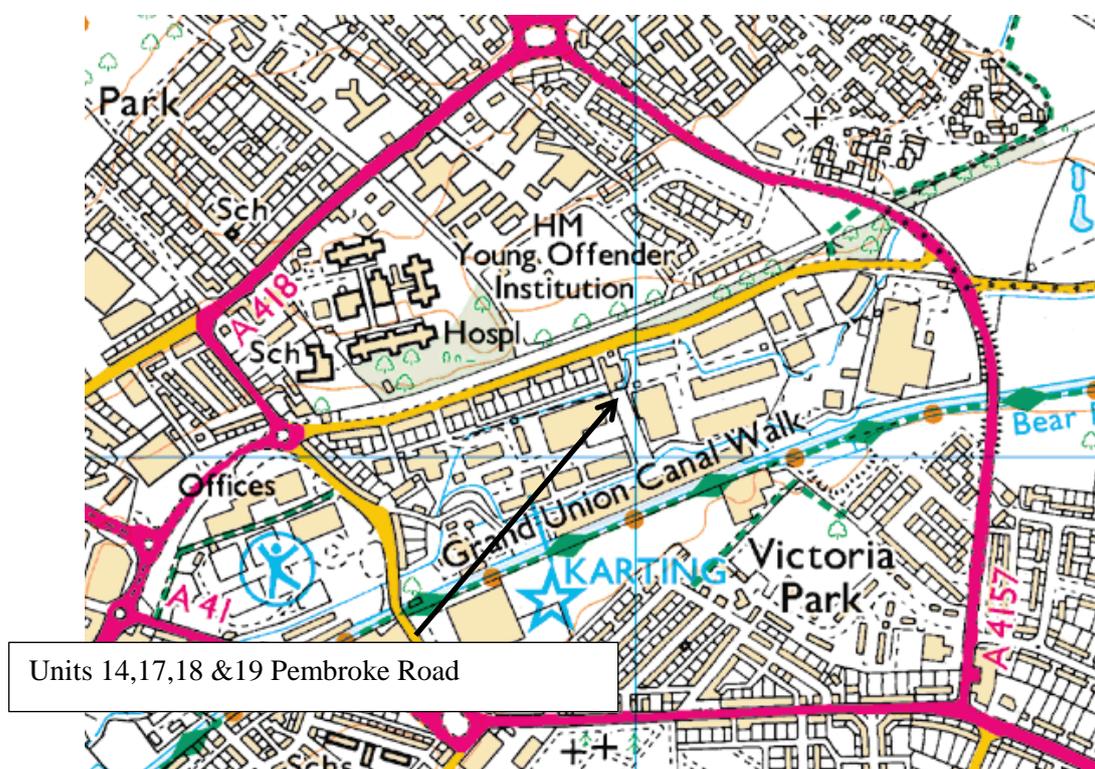
Figure 2 Location of AVDC's Properties at Pembroke Road

- 3.13 The Willows Estate is prone to flash flooding as it is near the source with a relatively small catchment. This means that there is minimal response time to erect protection, unlike Buckingham (6-8 hours) and Marlow (4-6 days).
- 3.14 AVDC's Operational Depot at Pembroke Road was the largest commercial business affected by the flooding within Aylesbury Vale (See Appendix 2).

- 3.15 A brook at Pembroke Road overtopped the banks and surcharged through the surface water drains and the rainwater harvesting system. Despite sandbagging/gel bagging there was still significant water egress into transfer/storage areas.
- 3.16 As this was a daytime event, staff managed to stop the floodwater from accessing our building – the maximum height of the water was approximately 30mm below the level needed to breach the refurbished offices. Had this been out of hours, our new offices would have been totally flooded with dirty water.

- 6.3 **Pembroke Road** - At Pembroke Road we are looking to make ourselves more resilient from a Business Continuity perspective. As we are in a flood plain and Stocklake is a main river we would need approval from the EA. Our proposals are a combination of:

- Raising the levels of our yard that flooded to that of the areas of the yard that did not flood,
- Providing site bunding, in effect protecting our buildings and stored dry recycling. We need to keep our material and buildings dry but also allow access and egress of vehicles at all times as it is an operating transfer station.

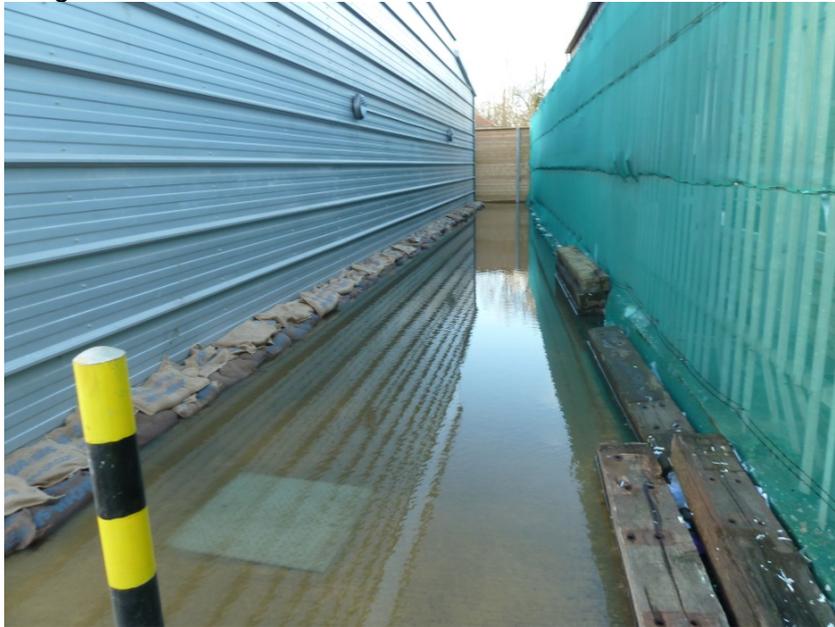
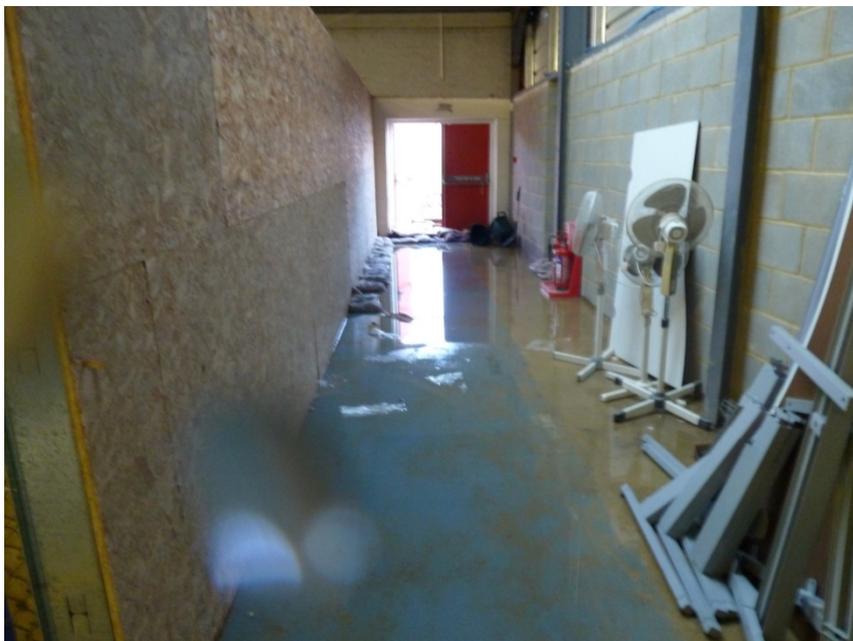
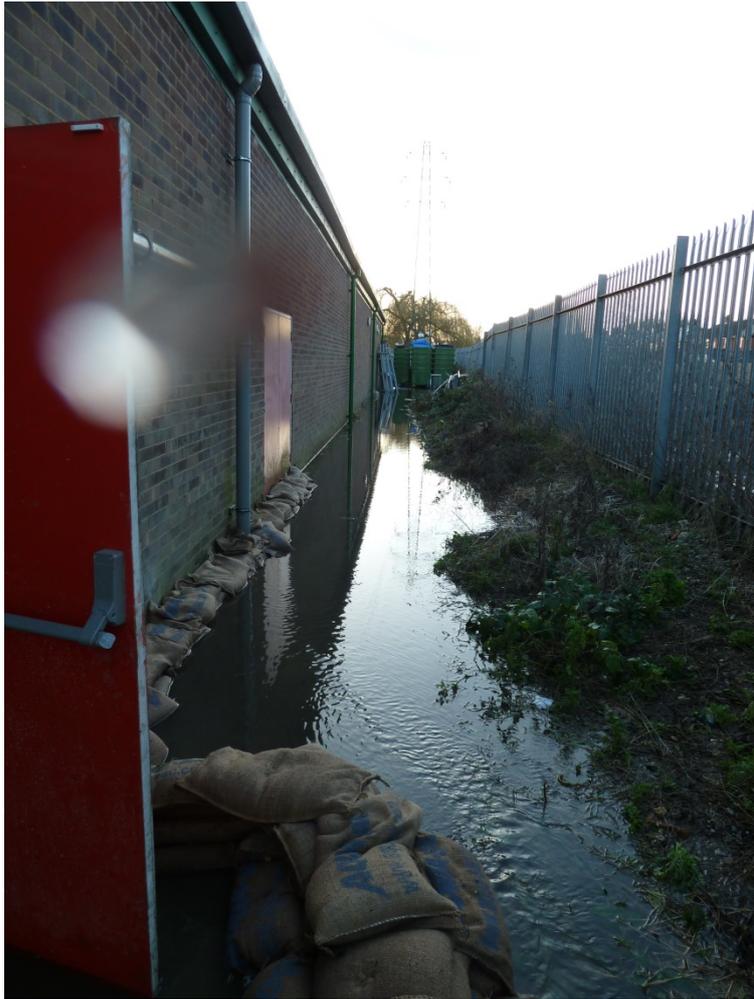
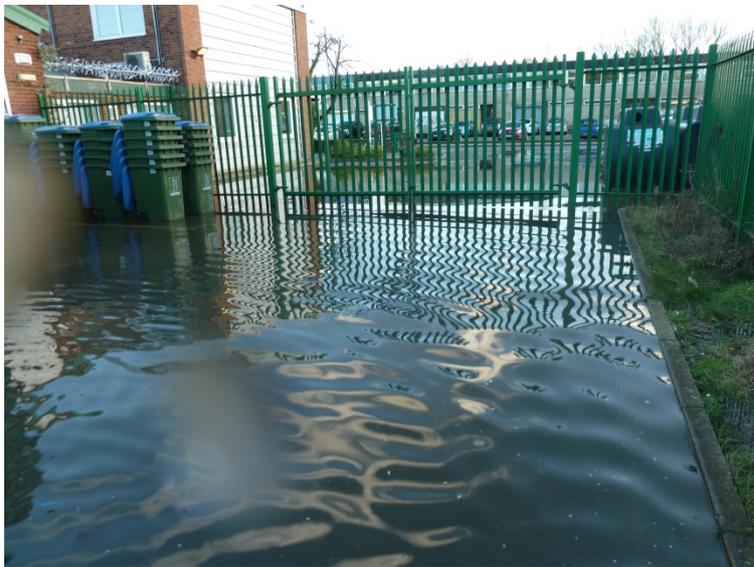
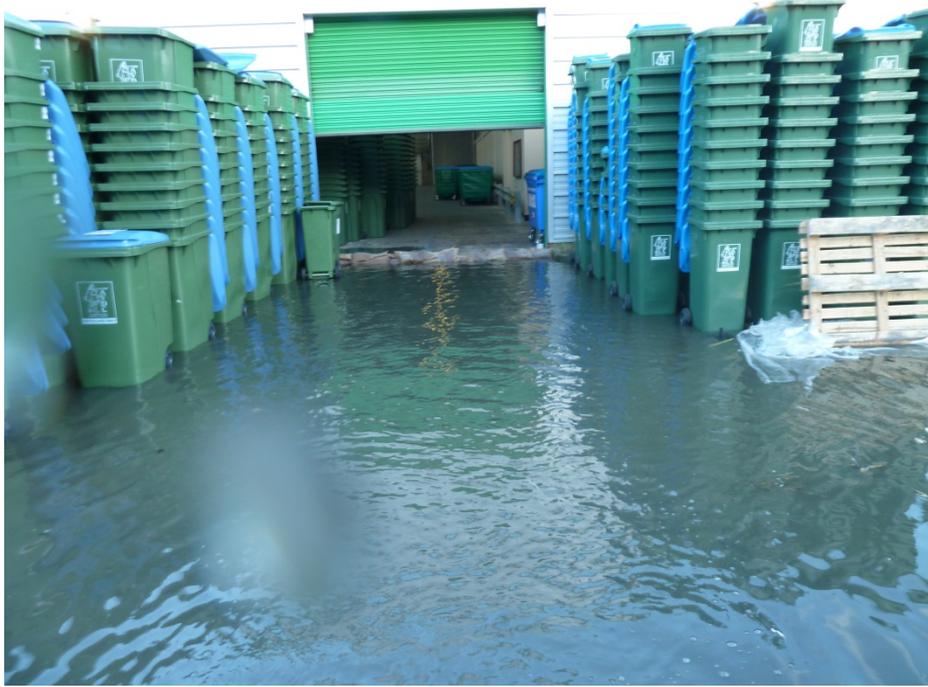
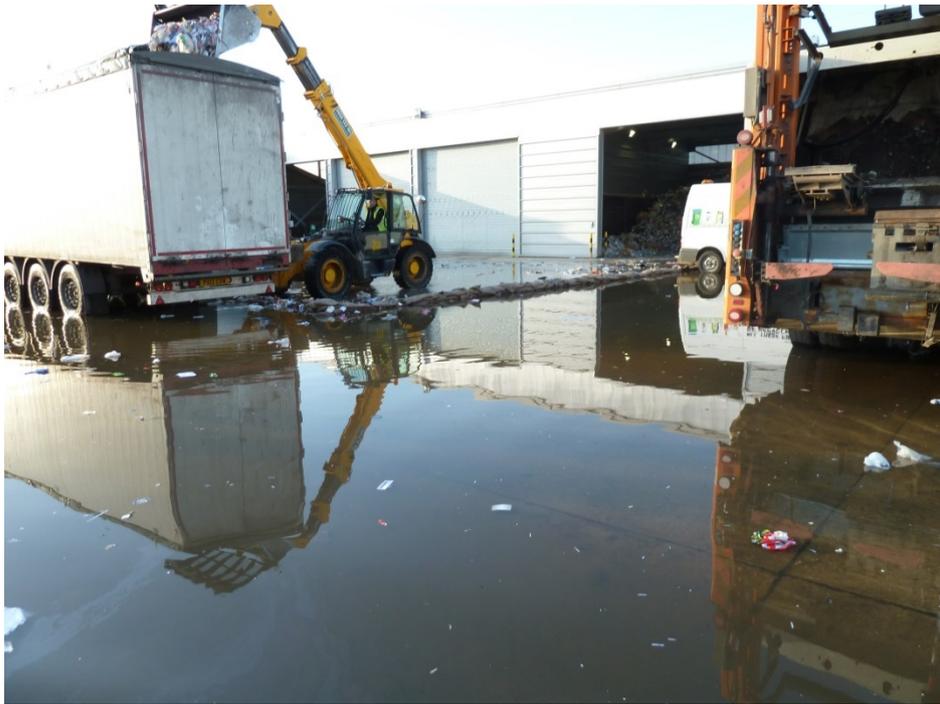
## Appendix 2 – Impact of flooding on the Council’s Pembroke Road depot

Water was surcharging from the drains. Staff believed that the dry recycling shed and its contents (valued at £150 to £200K) together with the caged area containing sports, election, communications and marketing and elections equipment was in danger.

Flood water rose 200mm between 08:30 to 09:30 and was overlapping doors. Staff assisted with the construction of sandbag in the yard/around the dry recycling shed. The water they were working in included raw sewage. Staff did not have wellington boots and were wearing (relatively) expensive work wear.

Due to the nature of waste service activities our own vehicles were offloading recycling and food waste with external vehicles also having to be loaded. This flow of vehicles created a bow wave that was topped over as vehicles passed by. Staff 'gel bagged' as much as possible so that the effects of drain surcharging would not enter the buildings. They managed to save half of the recycling. Bag walls were approximately 2' high with the yard approximately 18" deep.

Staff were unable to gain access to all of the protected Caged Storage Areas except one which had water ingress from an external door, managing to protect the Christmas Tree Lights as it was felt that these were the most valuable single item. Staff considered the gel bags to be largely useless in containing the flooding, although the bags prevented dirty water from entering. Any ingress would have rendered the offices unusable with staff relocation required until a deep clean had taken place.
