**Subject** Pinewood Studios - Phase 1 Ecological Monitoring  
**Date** 29 June 2018 **Job No/Ref** 253385-07

## 1 Introduction

## 2 2017 Monitoring Results

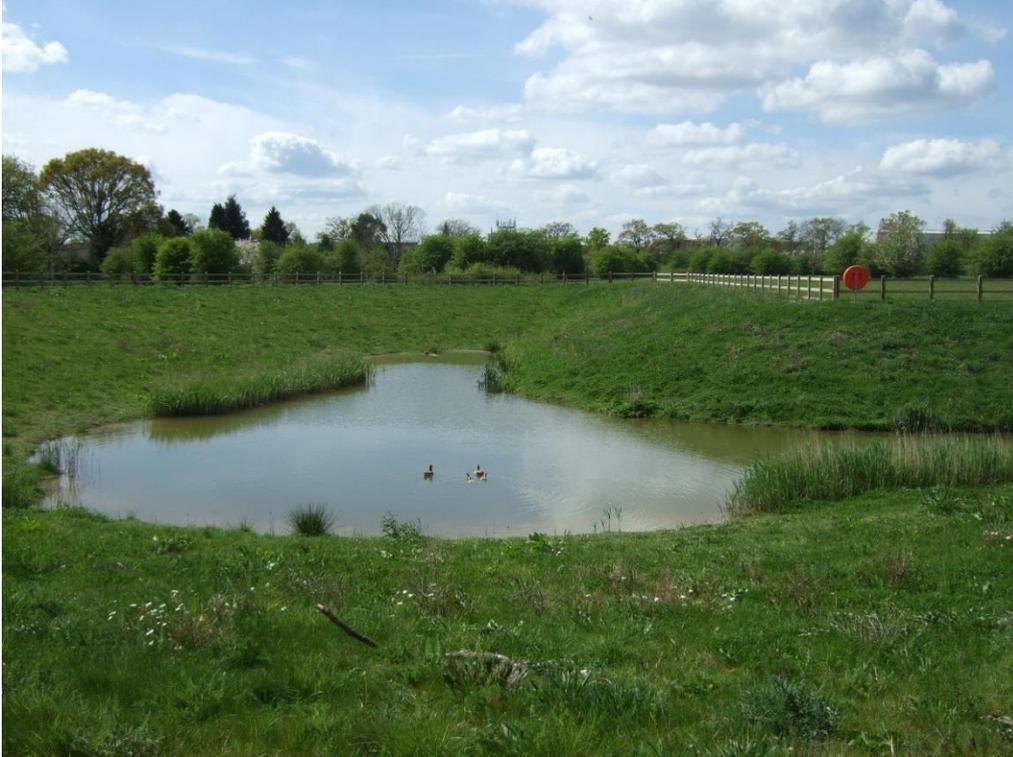
Photograph 1: April 2017 – a mallard family photographed on the southern pond. This photograph was taken approximately one year after the pond was created.

The two ponds created as part of the Phase 1 development proved attractive for waterfowl species with mallard and tufted duck both breeding in the habitat surrounding the southern pond. These species have not been recorded within the survey area previously. The northern pond has proved a successful foraging resource but was not used as nesting habitat for any bird species. It is thought that this is because the vegetation has not developed as quickly as that around the southern pond so does not offer as much protection from predation.

The ponds have established well and surveys indicate that they are becoming successful ecological resources. Egyptian geese, ruddy darter and black-tailed skimmer dragonfly, and common blue butterfly have all been recorded on site in association with these ponds and mallards and tufted duck nested on the banks of the southern pond in 2017.

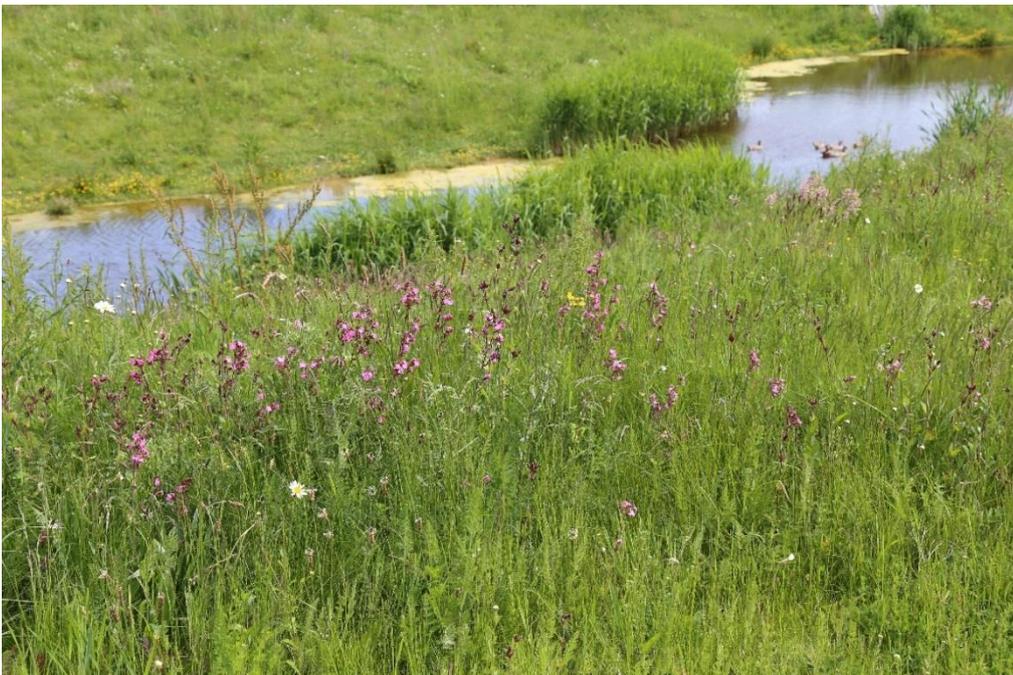
Photograph 2: May 2017 – demonstrating the vegetation growth around the southern pond and the ongoing presence of nesting birds (mallard family pictured in the background).

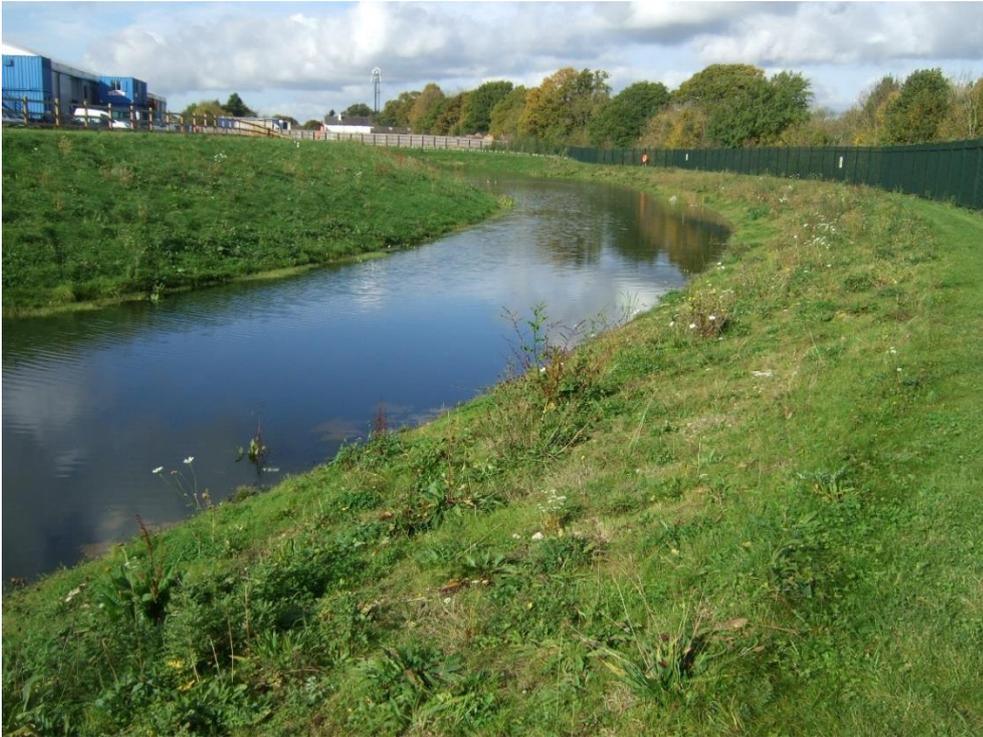
Photograph 3: October 2017 – the northern pond. Photograph taken approximately 1.5 years after the pond was created.

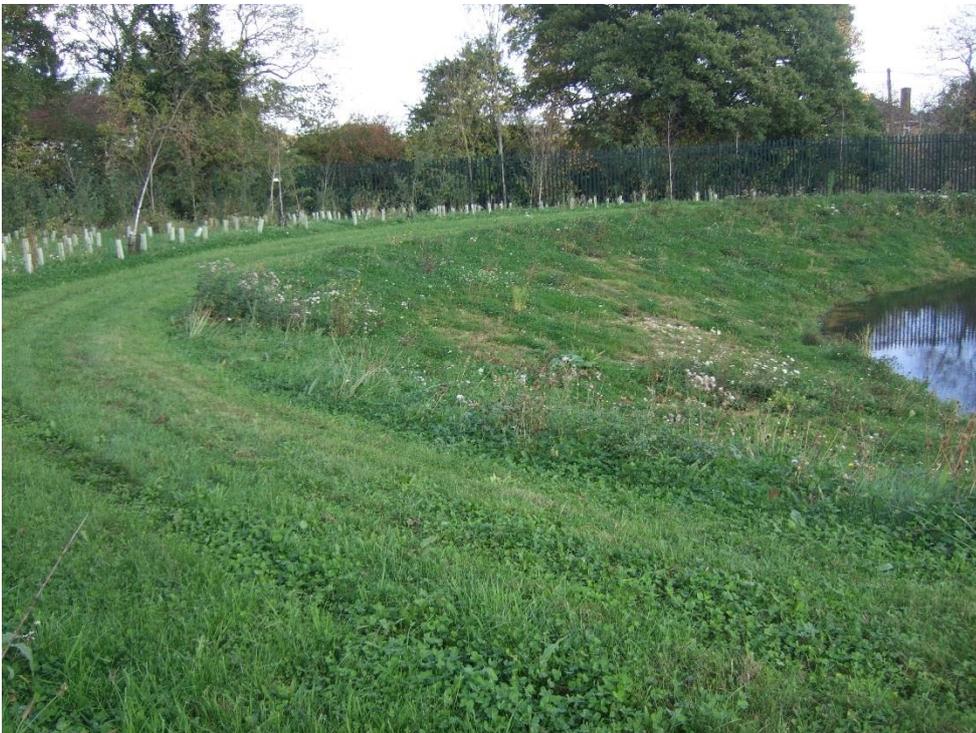
Photograph 4: October 2017 – the northern bank of the northern pond showing the tree planting along the outer edge to enhance the Sevenhills Road tree corridor.

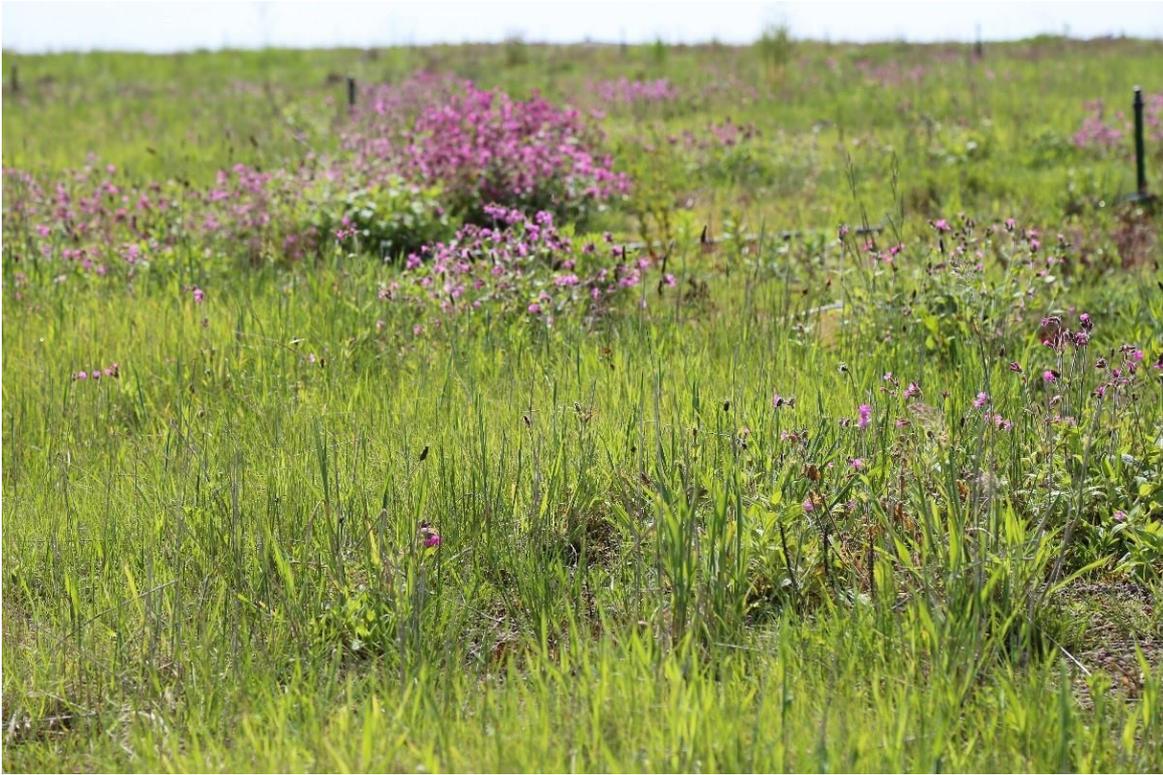
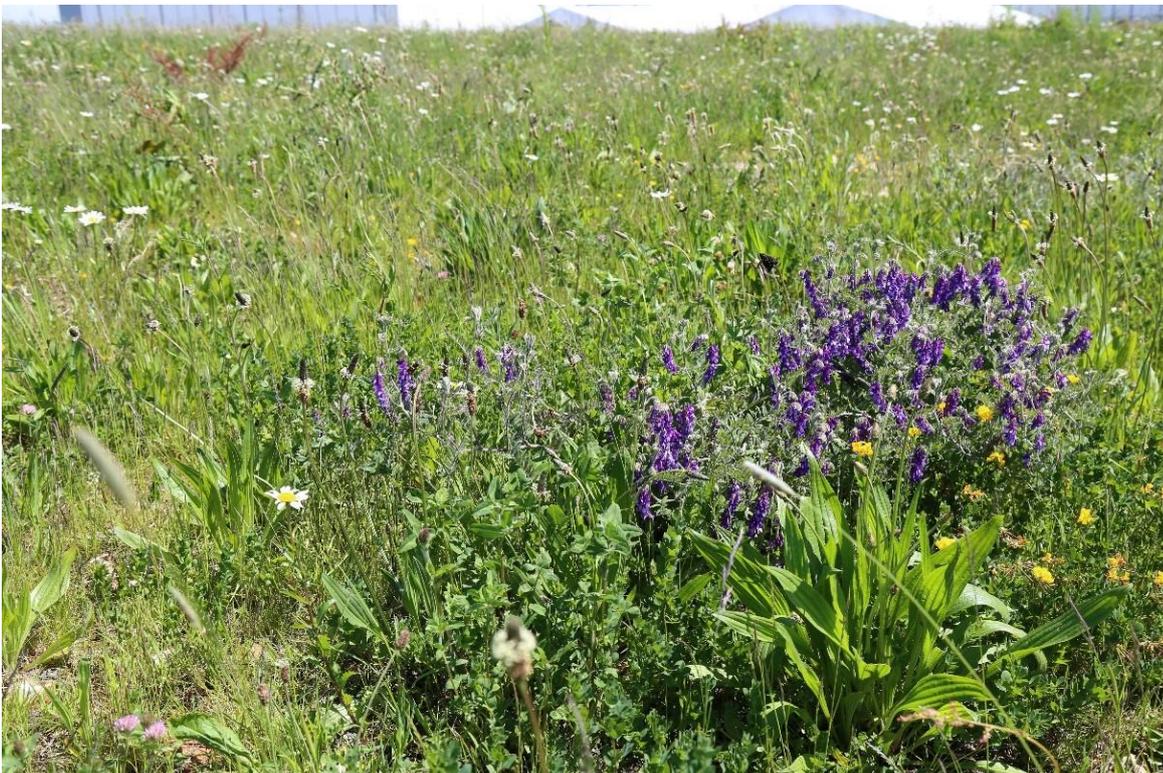
Photograph 5 (above) and Photograph 6 (below): photographs taken on the green roofs in May 2017, under a year after they were seeded.

Initially, all the roofs were seeded with the same species mix, but through natural colonisation, each has developed slightly differently, providing a suitable environment for birds, particularly skylark, and a range of invertebrate species. Roofs 3, 4 and 5 developed with a more meadow-like in nature, with a greater proportion of grass species, compared to roofs 1 and 2, which are becoming dominated by more vigorous species (such as sow thistle).

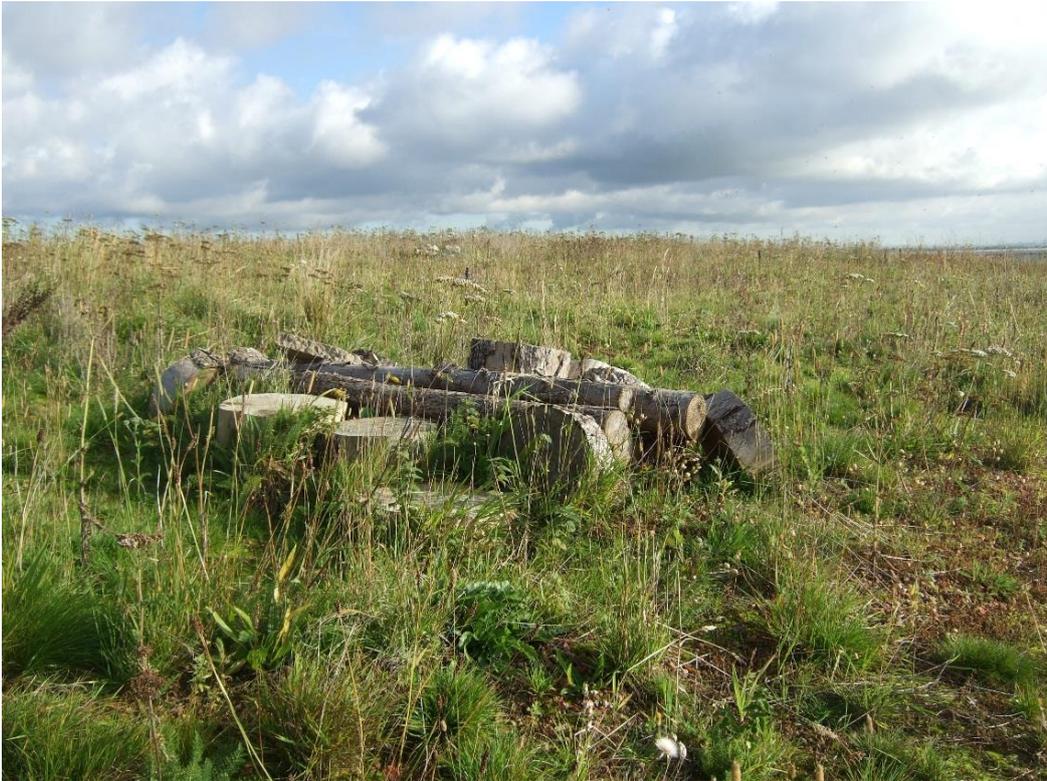
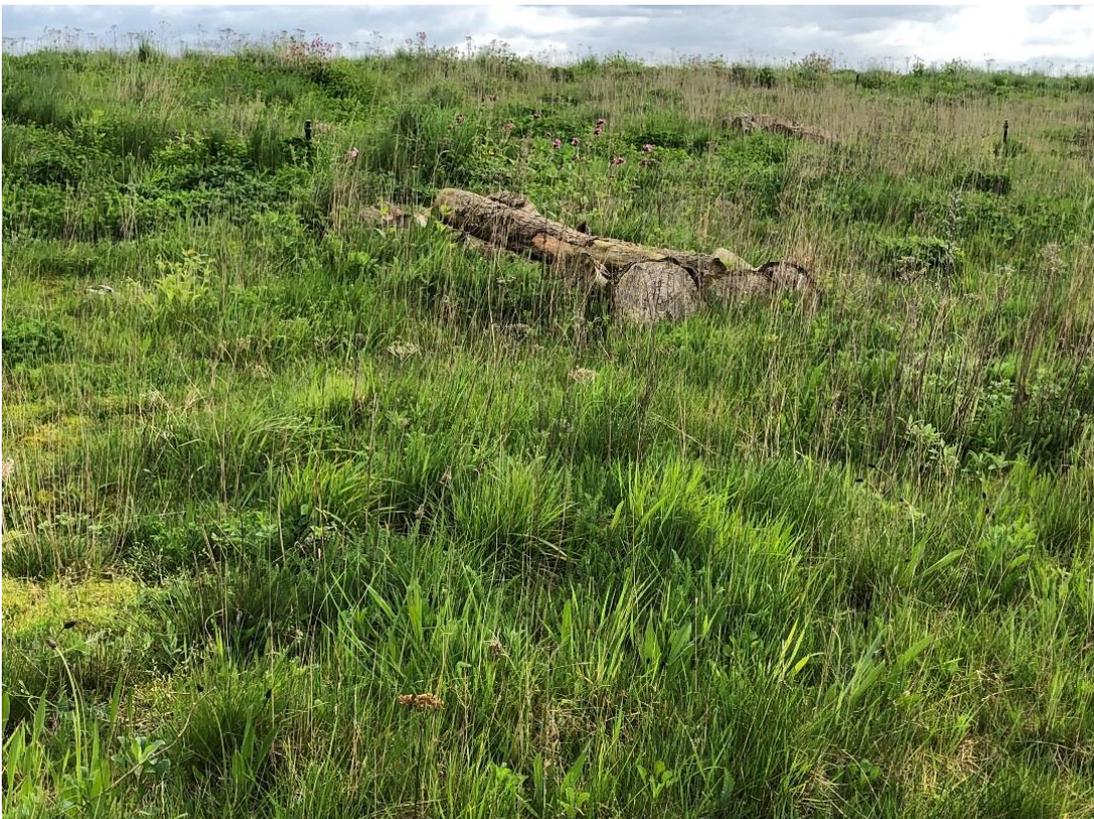
Photograph 7 (above) and Photograph 8 (below): photographs taken of the log piles and surrounding vegetation on the green roofs in October 2017. The range of habitat types can also be seen with some more tussocky areas and some barer substrate patches, which give rise to a more diverse species assemblage.

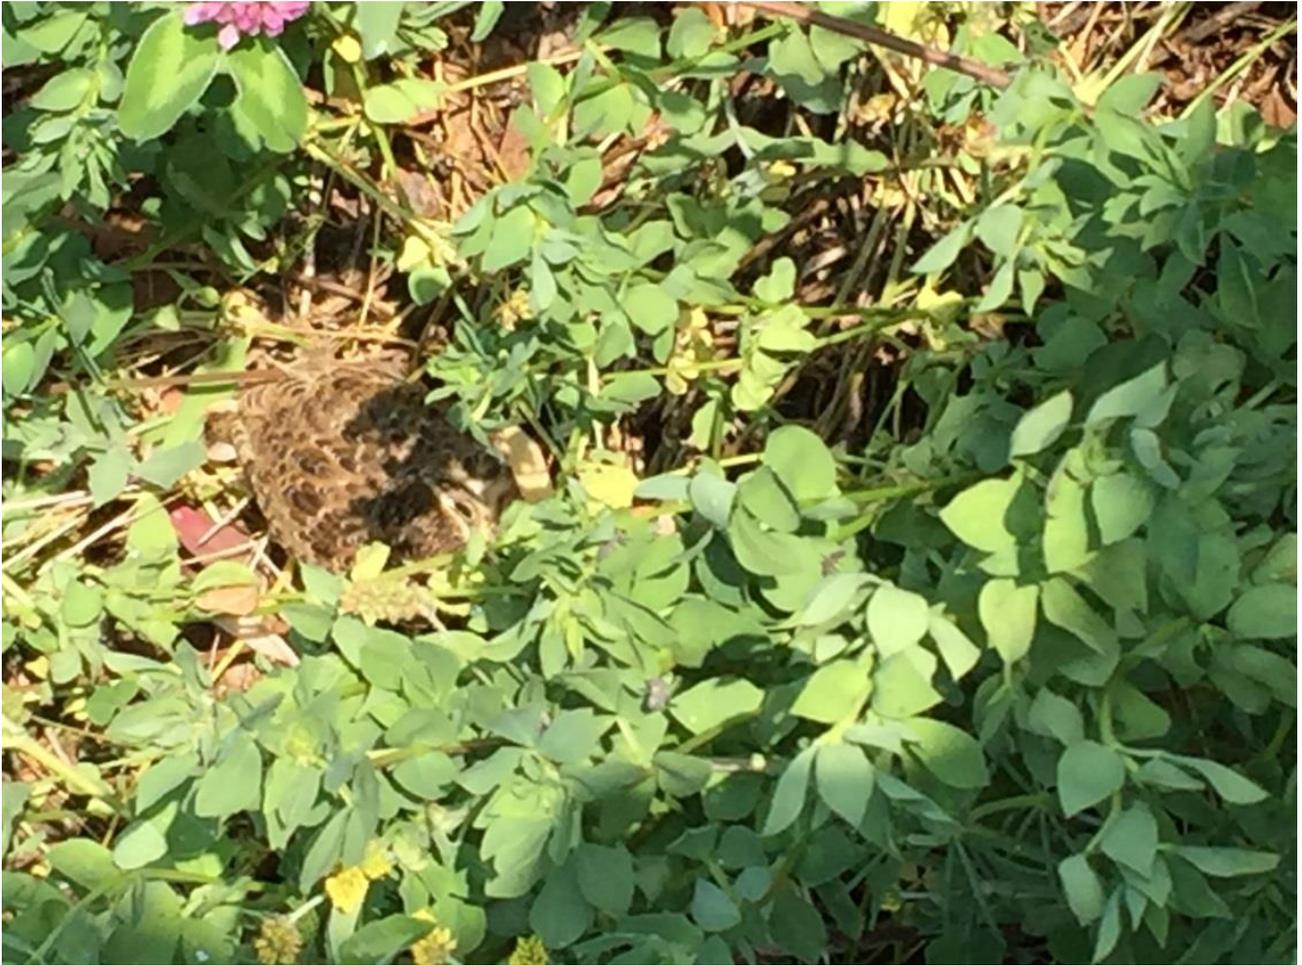
Photograph 9: May 2018 – a skylark nest on one of the green roofs, in amongst the tussocky vegetation.

A range of bird species have been recorded using the green roofs for foraging and nesting. Of key importance is the confirmation that two of the roofs supported nesting skylark during the breeding season. In addition, during the August and October surveys, more skylark were showing interest in all five roofs.
