Holland Farm mitigation

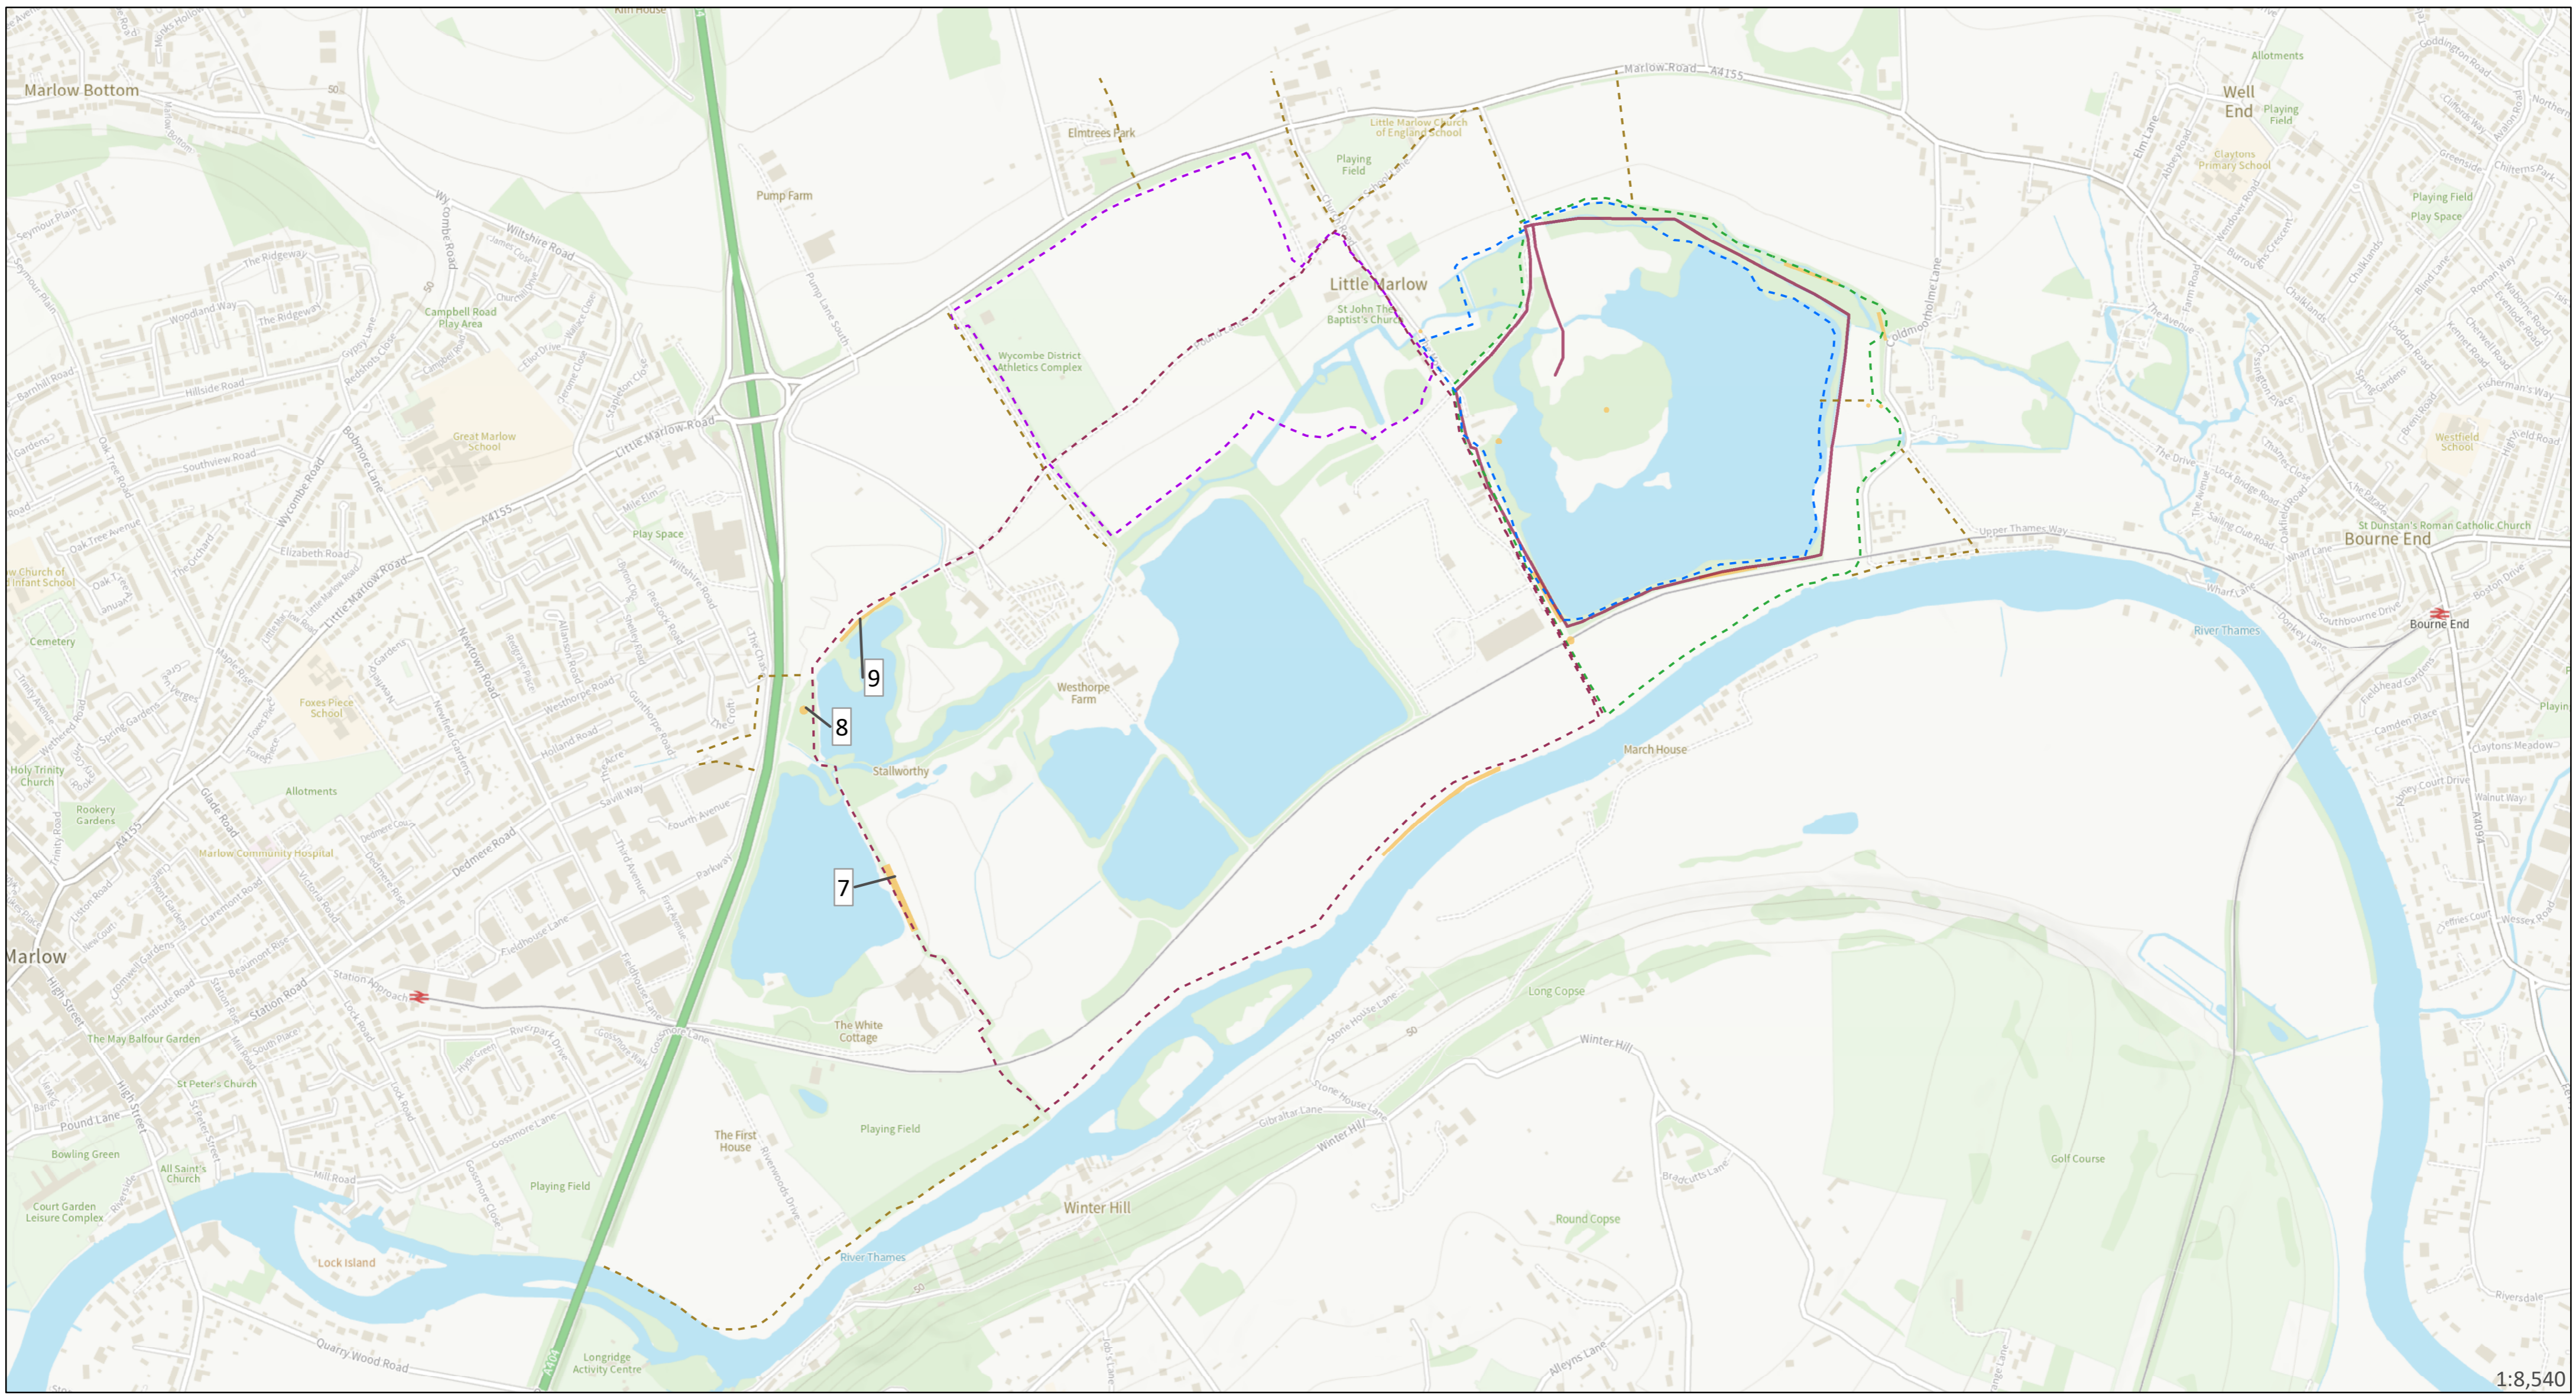
- Holland Farm Circular Route
- Thames Path Loop
- Running Track s. 106
- Thames and Spade Oak Loop
- Spade Oak Loop
- Other routes

- 7.** Footpath leading past the Crowne Plaza Marlow and connecting the Thames Path with the area around Westhorpe House; key area for improvement as the path enables a circular trail around the LMLCP. This section of path is very narrow, overgrown with vegetation, muddy (see Figure 7) and has a littering issue. BC's proposal of constructing a new footpath here is considered a key measure for the park. It is to be noted that this will require a new Permissive Path Agreement with the landowner(s).

- 8.** Intersection of various footpaths to the north of Crowne Plaza Marlow; near residential area and the A404. This location offers an opportunity for improving signage, as it is easy to get lost here (for example heading towards the A404 or private land belonging to the angling club); a new waymarker could signpost the LMLCP circular trail.

- 9.** Current footpath / cycle path to the north of the western lakes and Westhorpe House. BC's proposal to extend / enhance the cycleway here is considered to be an effective intervention, as there currently is only a very short well surfaced (compacted gravel) cycle path section to the north of Westhorpe House. The surfacing could be improved along the entire section of this path. It is to be noted that this will require a new Permissive Path Agreement with the landowner(s).
