**Our Client** : Miss Palminder Kaur Barar  
**Subject** : Webbers Cottage, Coleshill Lane, Amersham, HP7 0NS ("the Property")

## Arboricultural Consultancy for Covéa Insurance

# GEOTECHNICAL

Webbers Cottage, Coleshill Lane, Amersham, HP7 0NS

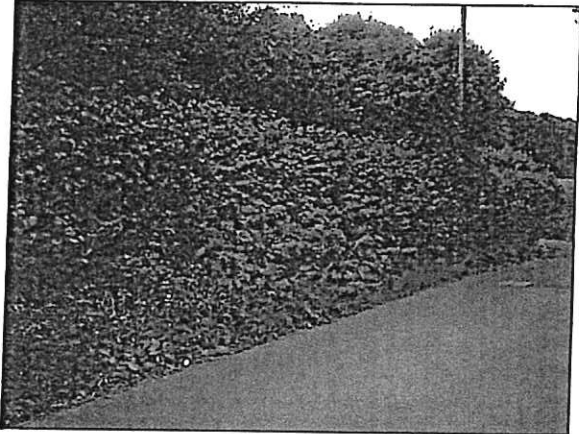
T1 - Oak

The Property has also been subject to level monitoring from 26 June 2017. The results display clear seasonal movement whilst T1 has been in-situ, which is a key indicator of clay shrinkage subsidence.

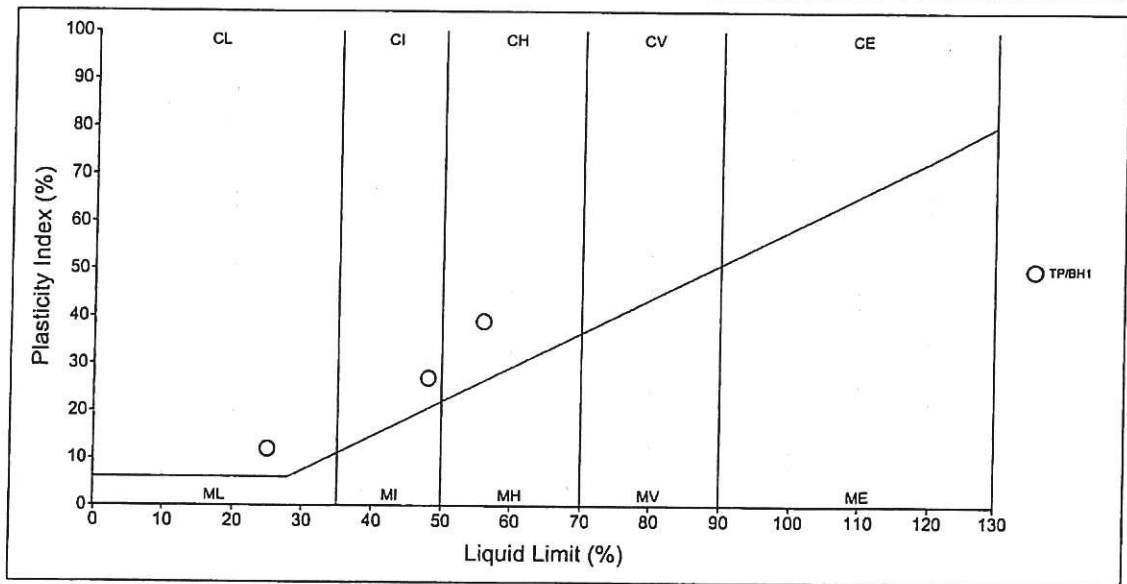
Plasticity Chart for Casagrande Classification

Lab Ref	Depth (m)	Description	BS:5930	NHBC Chapter 4,2
Samples from TP/BH1				
001	0.40	Soft brown sandy slightly gravelly CLAY . Gravel is fine and medium.	CL	Low
002	0.90	Soft brown sandy CLAY with rare gravel. Gravel is fine and medium.		
003	1.40	Soft brown/orange-brown mottled sandy CLAY with rare gravel. Gravel is fine	CH	Medium
004	1.90	Firm orange-brown/grey-brown mottled sandy CLAY with rare gravel and chalk. Gravel is fine, mdium and coarse.		
005	2.40	Very soft light brown/white mottled clayey slightly gravelly CHALK (with gravel of chalk). Gravel is fine and medium.	CI	Medium

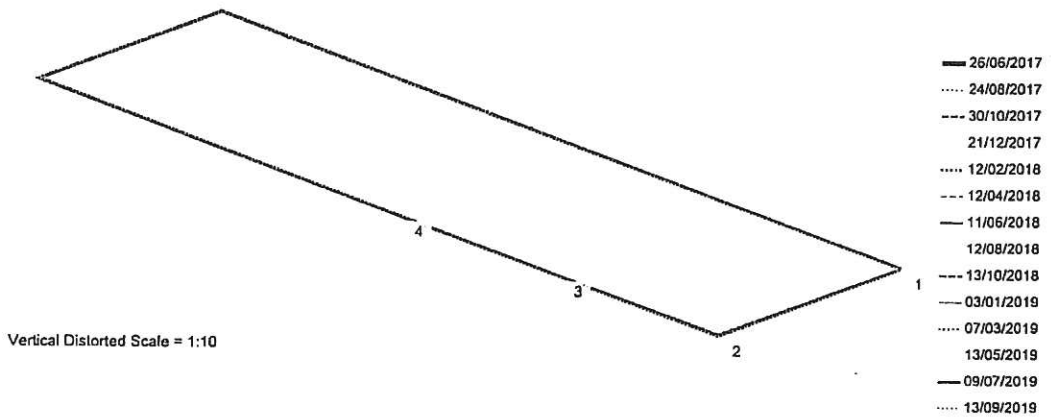
### Level Monitoring Displacement Map

The following image shows an isometric representation of the movement of the property, based on the Level Monitoring Stations that were installed.

Similar movement to Feb 18 noted.
