# Report on The Ridgeway Delivery Group Meeting and demonstration: Uffington

11<sup>th</sup> September 2019

Site visit to The Ridgeway at Uffington and the recent resurfacing.

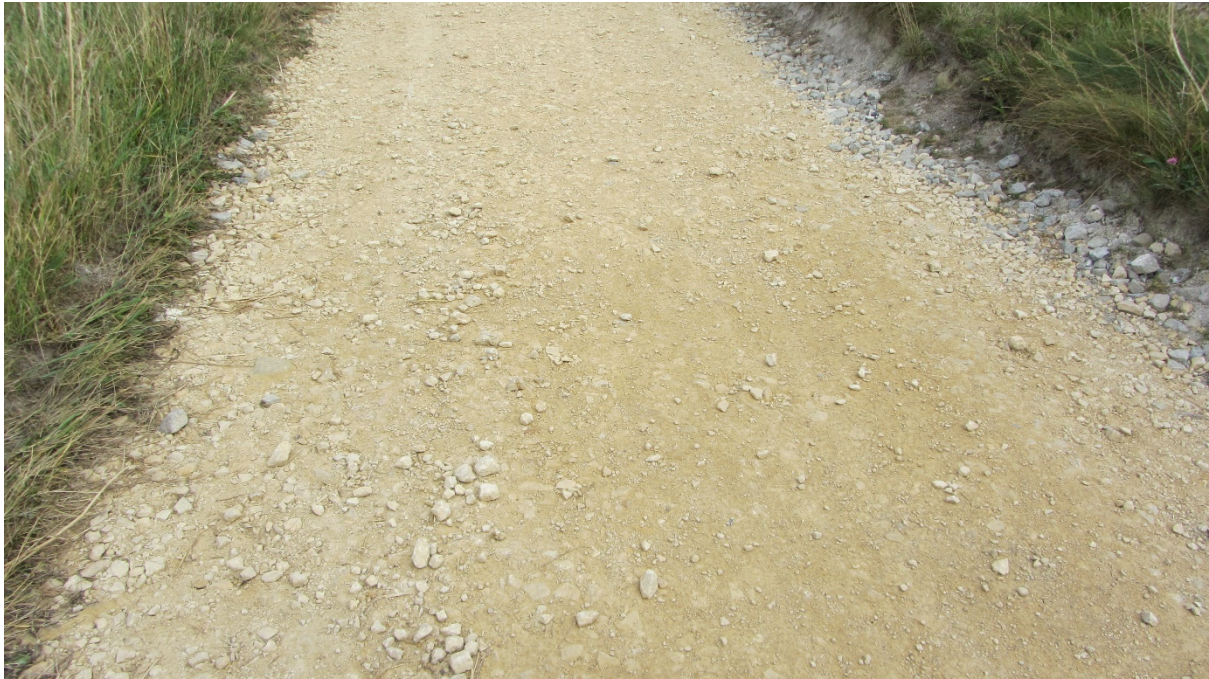
**The finished surface of limestone and finings**

The trail repairs at Uffington consisted of cutting out the sides of the track to fill in the central channel which was largely due to water erosion on the slope. The width was 30 feet across. Then a layer of local limestone, 250/300mm deep, was laid with a top binder of 40mm limestone down to dust.

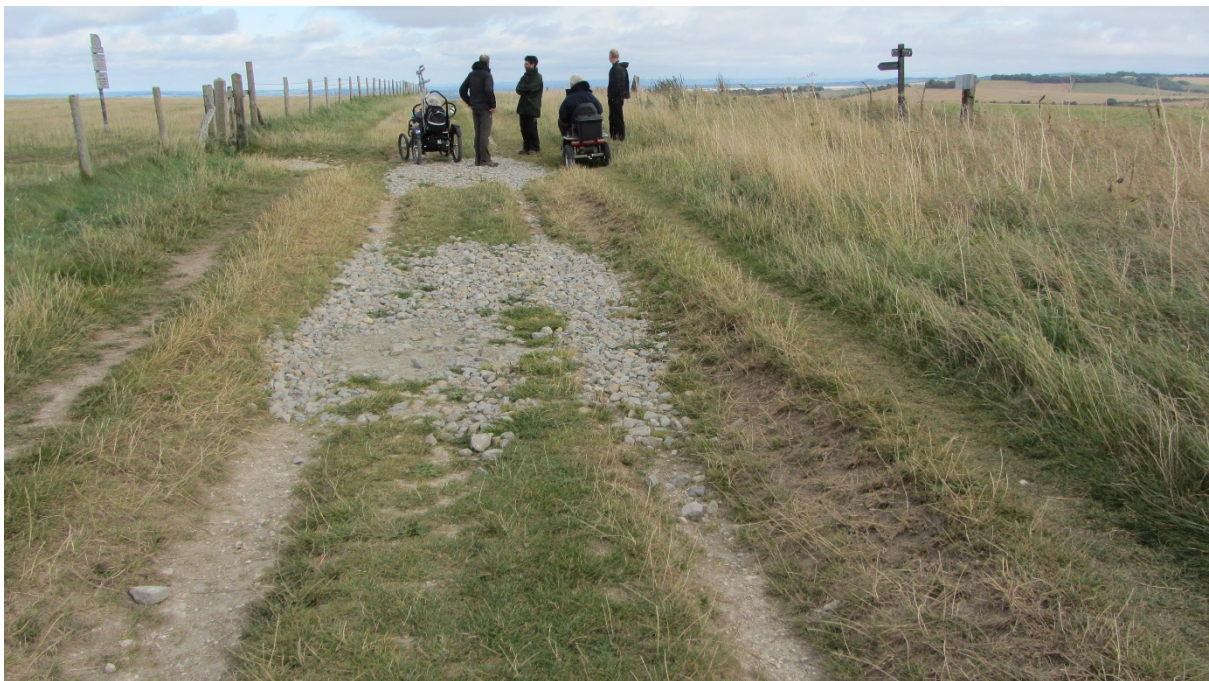
**A couple of disability scooters who used the same surface**

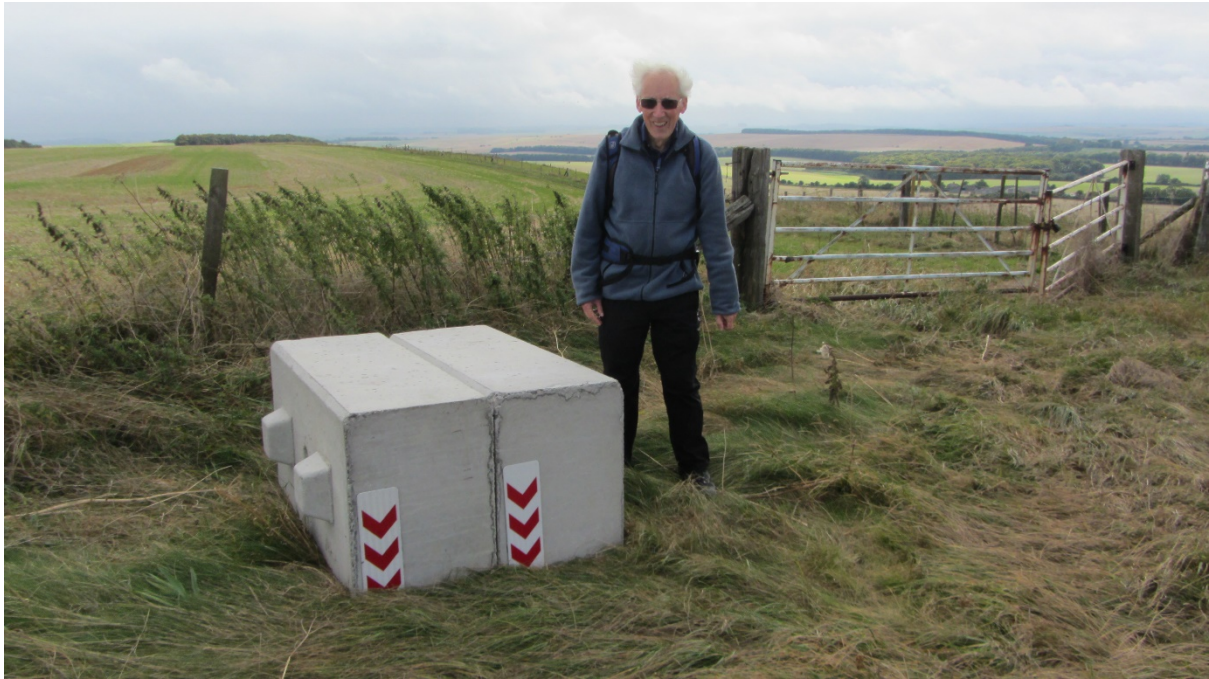
**Two of the concrete blocks used to restrict access during the repair and settling down 6 months**

The trail was restricted by large (cheap) concrete blocks with a 1500mm wide gap which stopped most vehicles, but not motor bikes. These blocks were removed after 6 months once the limestone had bedded in – see the point above about restrictions. Monitoring takes place and the rural police are taking an interest with intermittent visits. There appears to be no illegal use of this part of the trail, the only exception might be hare coursing and this is regarded as a police matter and part of their monitoring.

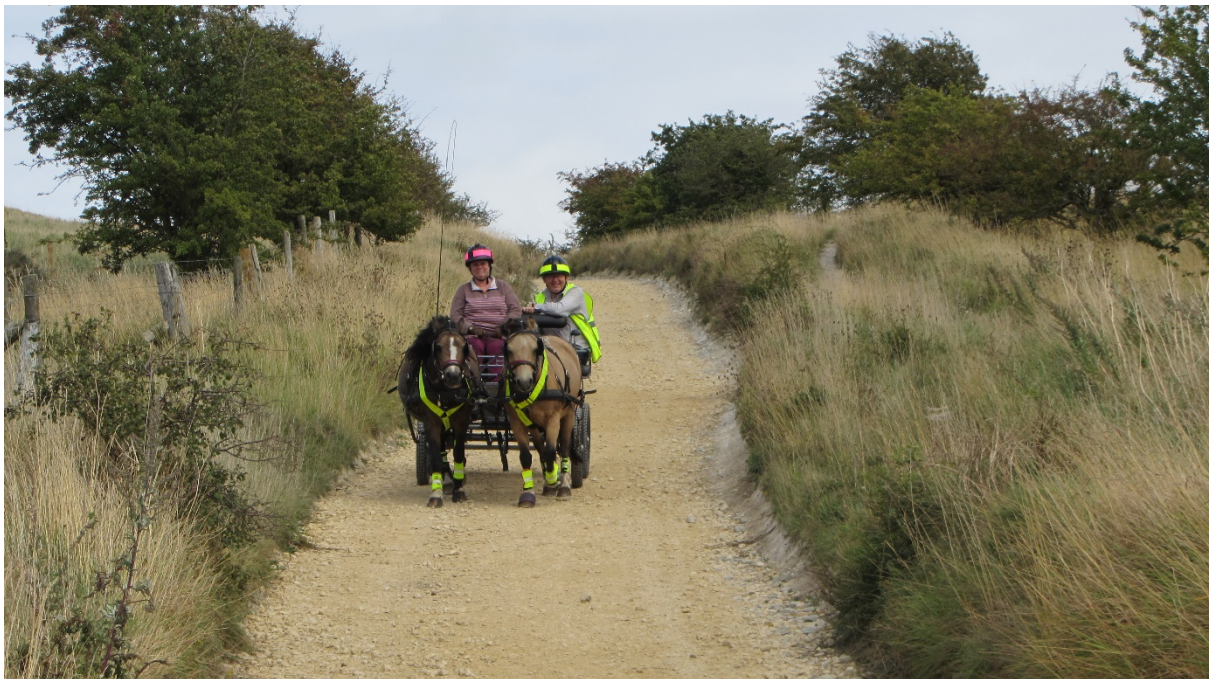
**A horse carriage driver on the new surface coming downhill**
