Little Marlow Sewage Treatment Works Liaison Committee agenda

Little Marlow Sewage Treatment Works Liaison Committee minutes

Site	LITTLE MARLOW STW (WOOBURNVALLEY), LITTLE MARLOW STW (WOOBURNVALLE, Y), BUCKS, -	Permit Ref	CNTD.0058		
Operator/ Permit holder	THAMES WATER UTILITIES LIMITED.				
Date	19/07/2023	Time in	10:00	Out	13:23
What parts of the permit were assessed	Wastewater Treatment Works / STW settled storm sewage, Wastewater Treatment Works secondary treated sewage effluent				
Assessment Type	Site inspection: Wastewater Treatment Works - Operator Self Monitoring (OSM)	EPR Activity:	Water Discharge		
Recipient's name/position	CAR form Inbox				
Officer's name	Jackie Outhwaite	Date issued	02/08/2023

Little Marlow wastewater treatment works (WwTW) is regulated under Environmental Permit number **D 0058**. There is also a permit for the compensation flow to the River Wye numbered 1334. Population equivalent of 177,415. This report relates to an inspection carried out on 18 July 2023.

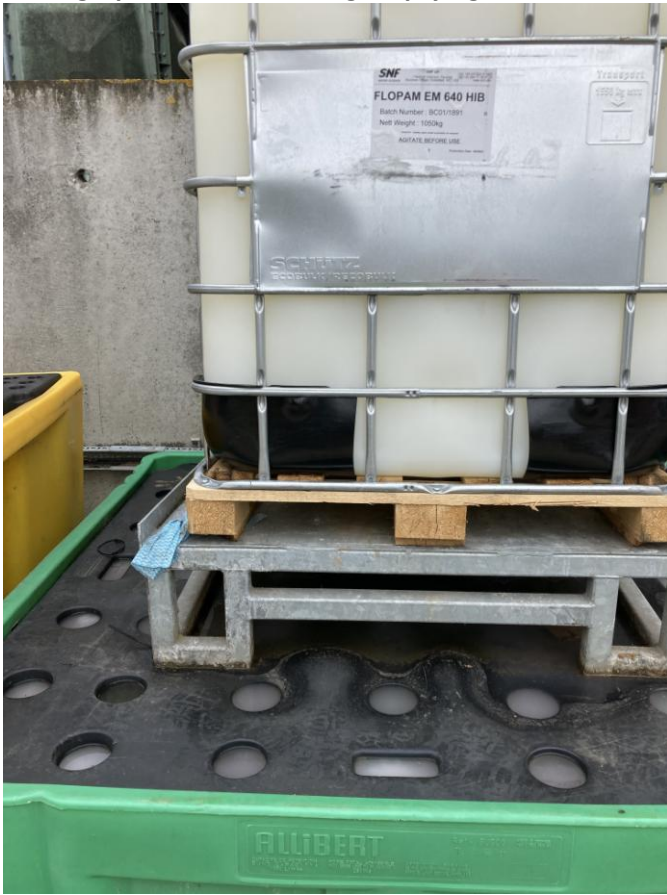
Photograph 1 - Bund needing emptying

During the inspection I noticed the bunded trays of 2 IBCs were filled with what looked like water and a white coloured liquid - see photograph 1. This was highlighted to [REDACTED] while on site.

ACTION – Please ensure the bunds are emptied and no liquid can escape from the containers or bunding trays.

Section 4- Action(s)			
Where non-compliance has been detected and an enforcement response has been selected above, this section summarises the steps you need to take to return to compliance and also provides timescales for this to be done.			
Where the CCS Category is marked N/A then the specified action does not relate to a permit condition.			
Criteria Ref.	CCS Category	Action Required / Advised	Due Date
See Section 1 above			
OA01	N/A	Please ensure the bunds are emptied and no liquid can escape from the containers or bunding trays.	16/08/2023
